VAILLANCOURT FOUNTAIN CONDITIONS ASSESSMENT

SAN FRANCISCO, CALIFORNIA
[24146A]

PREPARED FOR
San Francisco Recreation and Park Department

June 2, 2025

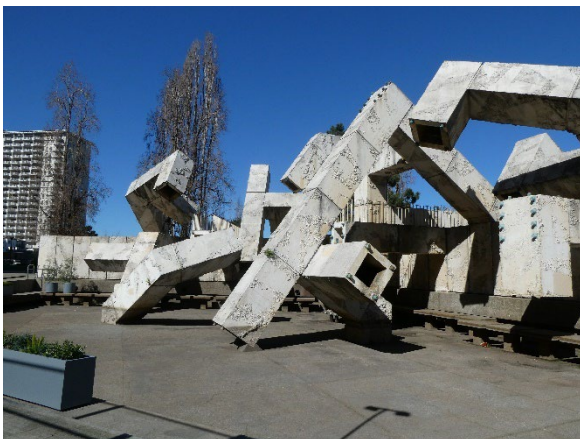
Typical overall condition of concrete pool, looking north.

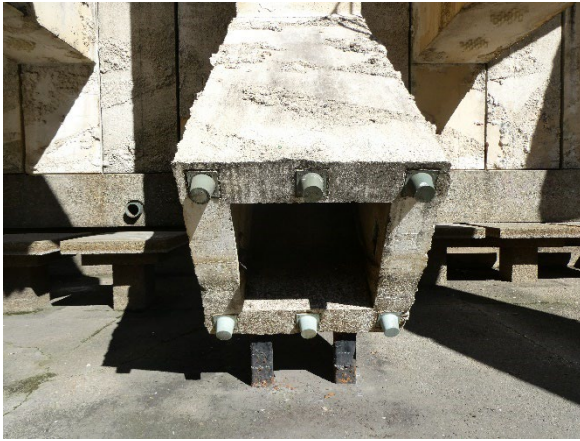
Typical condition of concrete pool and connections between concrete pool and hollow pre-cast concrete “arms,” showing cracking, biological growth, soiling, and corrosion at connections.

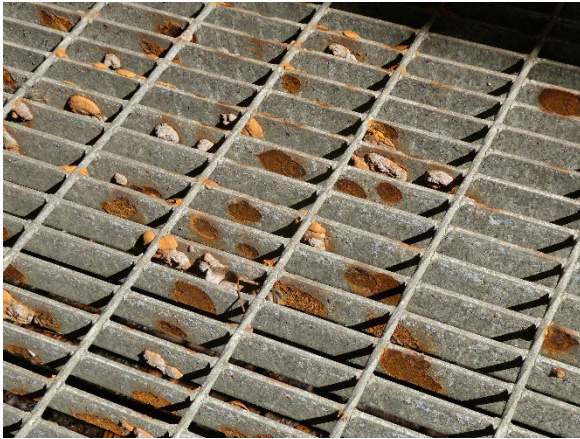
Typical corrosion at metal grate over sump pit.

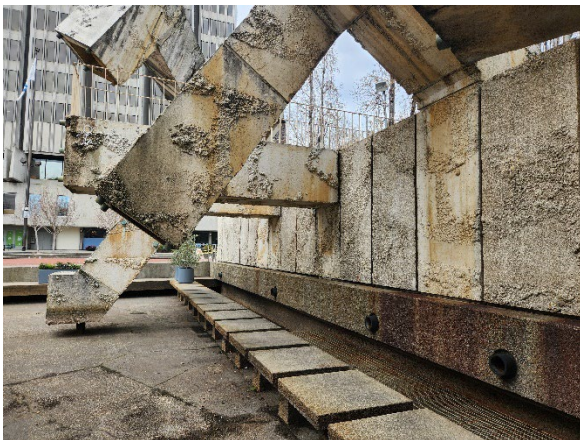
The concrete pedestals are generally in good condition, exhibiting some chipping at the edges and soiling, but otherwise appear sound without significant cracking, incipient spalls, or other spalling.

Typical overall condition of concrete “lily pad” pedestals, north side of fountain, looking west.

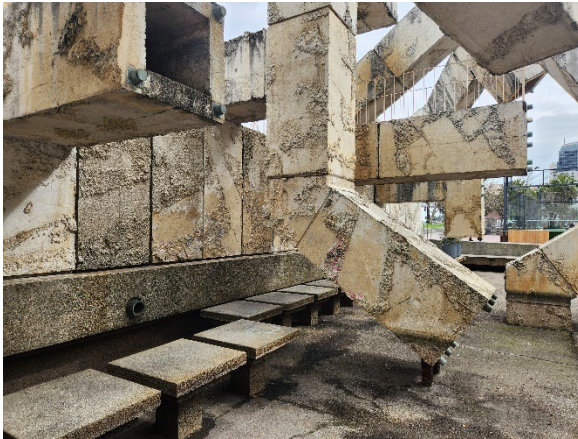
Typical overall condition of concrete "lily pad" pedestals, east side of fountain, looking southeast.

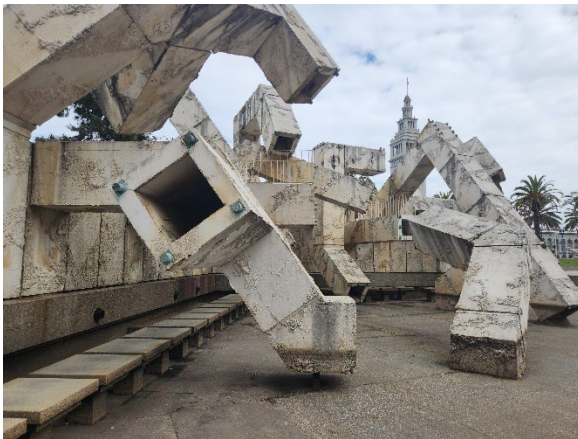
Typical overall condition of concrete "lily pad" pedestals, north side of fountain, looking east.

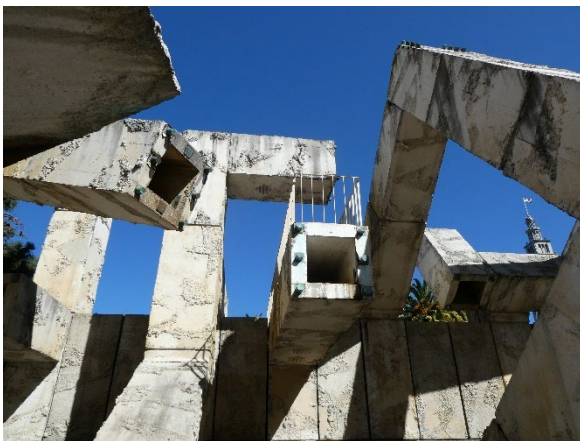
The concrete of the pre-cast concrete arms of the fountain is generally in fair to poor condition. Most exhibit some combination medium to large cracks, as well as spalls and incipient spalls. The majority of this deterioration appears to be a result of moderate to severe corrosion of the steel reinforcing within the pre-cast sections. A pattern of more significant cracking was also observed at high stress locations such as at structural transitions and connections. Exposed edges and both interior and exterior corners appear the most vulnerable to this type of deterioration. In particular, there is advanced corrosion in most of the locations where the bronze caps sit at the ends of the steel reinforcing, suggesting that galvanic corrosion may be an exacerbating factor, especially in the marine environment. In one location the cap is missing, and the steel rod within could not be verified. There is ferrous staining in numerous locations where iron oxides have been carried down the face of the elements with the flow of water. There is biological colonization in the form of algae or lichen colonies on the surface of the concrete, as well as limited observed plant colonization in the form of ferns at the joints between the pre-cast sections, which is indicative of retained or infiltrating moisture. There is dark soiling running down from many of the horizontal or nearly horizontal

Overall view and condition of hollow, pre-cast concrete arms of fountain, looking east.

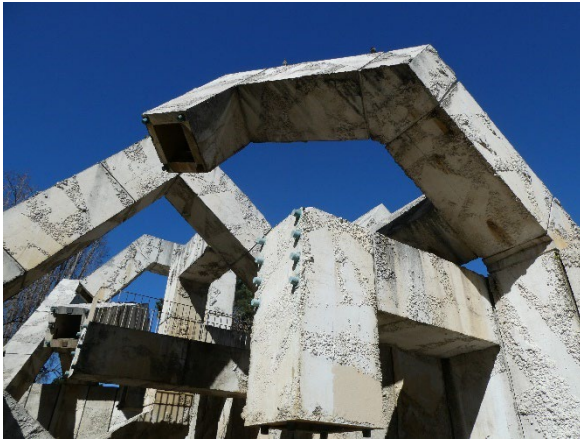
Overall view and condition of hollow, pre-cast concrete arms of fountain, looking north.

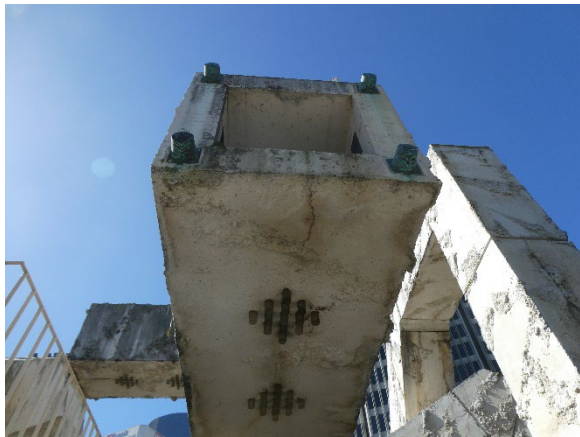
Central crack at lower side of projecting column, typical condition. Northeast elevation pictured.

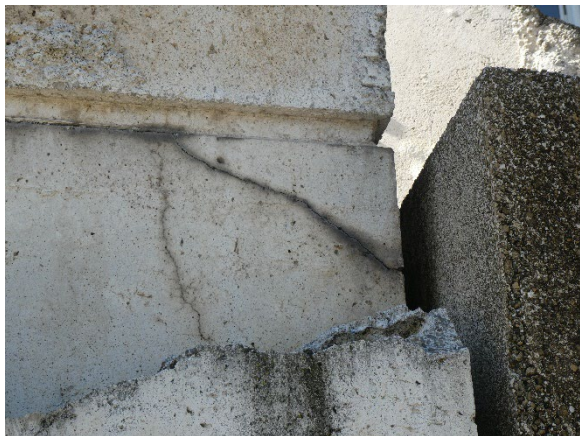
Incipient spalling and cracking at joint of vertical column, typical condition. Northeast elevation pictured.

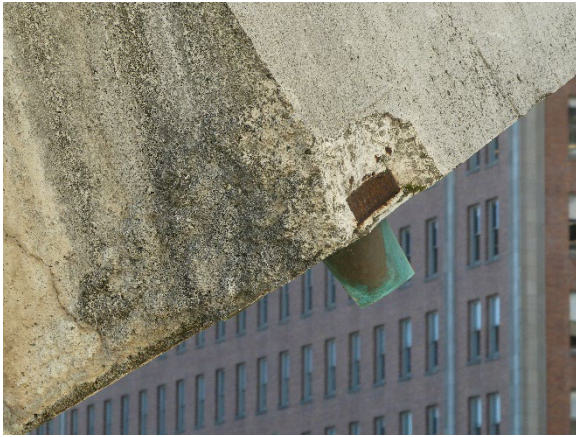
Spalling at the outer corners of the projecting column, typical condition. Image taken facing south.

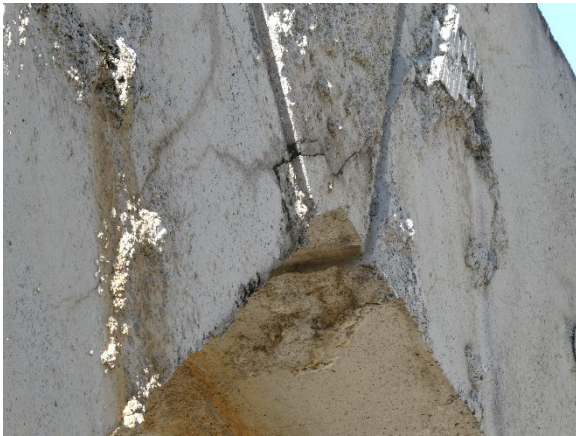
Incipient spall and cracking at joint of projecting column, typical condition.

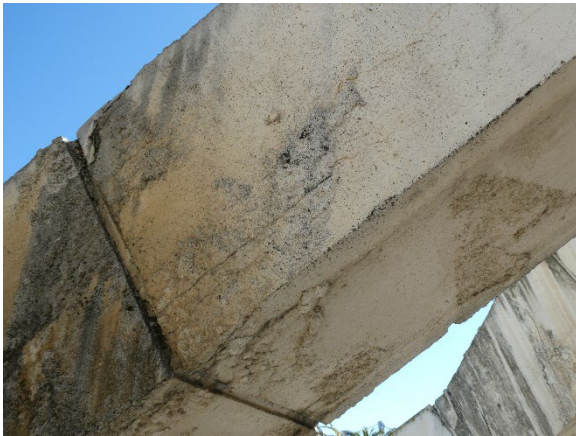
Cracking at the joint along the underside and side of projecting column, typical condition.

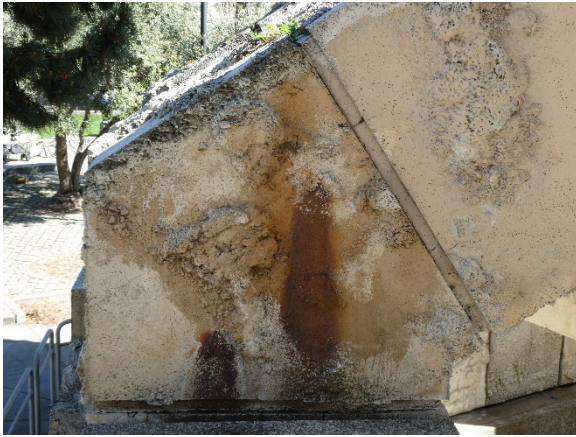
Corrosion of metal fixtures, typical condition. Photo facing west from viewing platform.

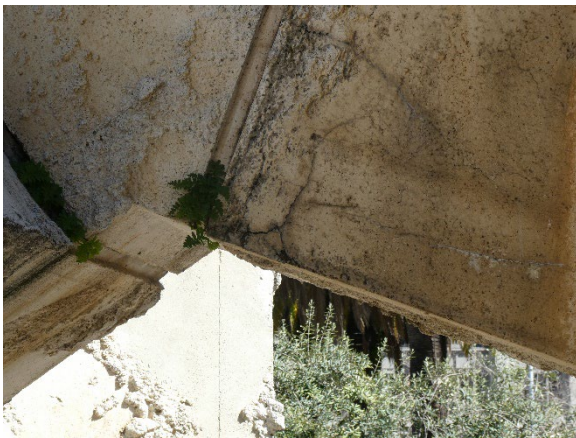
Incipient spalling and cracking at joint of projecting column, typical condition. Biological growth within several cracks.

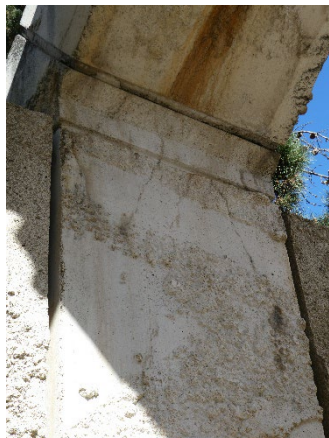
Cracking at joint along the underside of projecting column, typical condition.

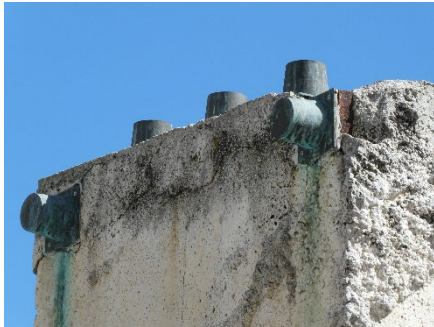
Spalling, incipient spalling, cracking, and corrosion of copper fixtures. Typical condition.

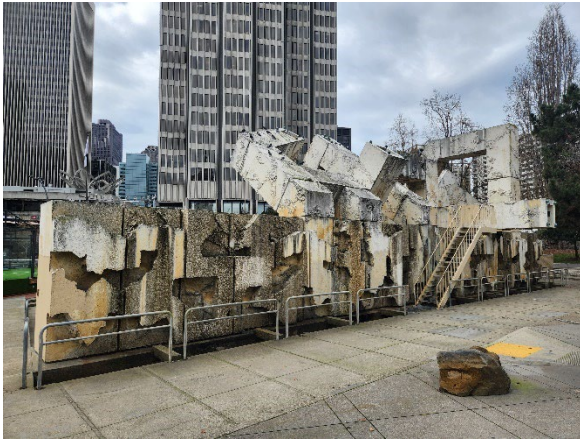
Observation of the pre-cast panel wall of the fountain was limited to the visible faces of each section, but from these surfaces it appears to be in generally fair condition, exhibiting early signs of deterioration. There are areas of crazing with hairline to small cracks, particularly in the irregular projections on the rear face of the panels; these cracks are most likely the result of surface shrinkage during the drying and curing process. Some small cracks run from edge to edge along a non-linear, irregular path, which could be from a variety of causes, including thermal stress or settlement. There are some instances of spalls and incipient spalls, most often at the upper corners where reinforcing, anchors, or other ferrous embedments have corroded. There is widespread discoloration from a variety of sources: efflorescence, soiling, ferrous staining, localized graffiti (and overpaint), and suspected mineral encrustation. There is also biological colonization of the surface primarily from algae and/or lichen, indicative of retained moisture which can contribute to the corrosion of reinforcing in the concrete.

Overall view of the hollow, pre-cast concrete panel wall, east side of fountain looking northwest.

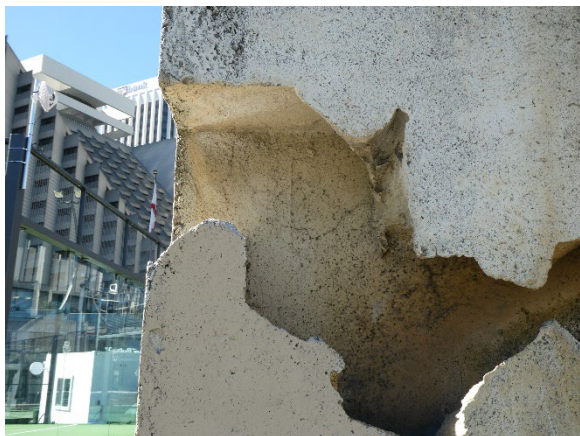
Hairline crack, typical condition. Southern edge of the northeast elevation pictured.

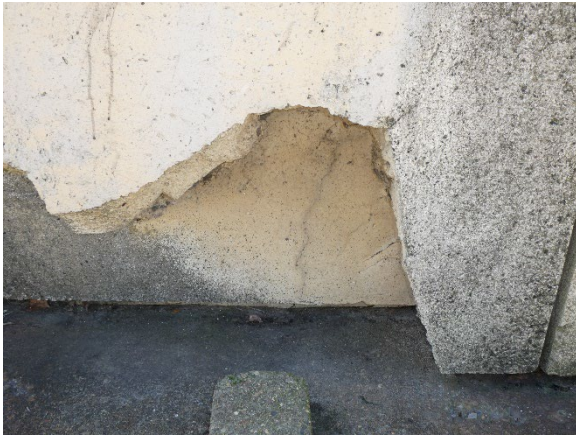
Cracks at base, typical condition. Northeast elevation pictured.

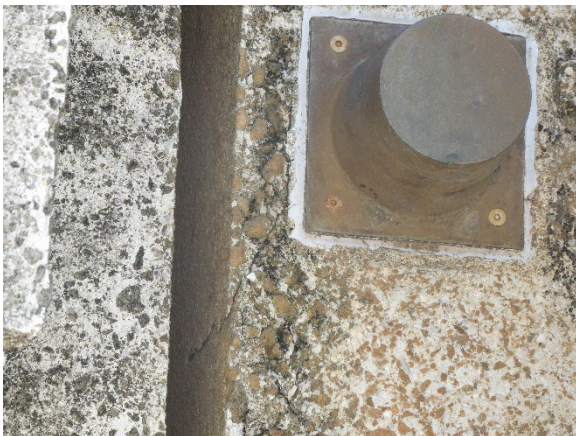
Incipient spalling adjacent to metal fixture, typical condition. Northeast elevation pictured.

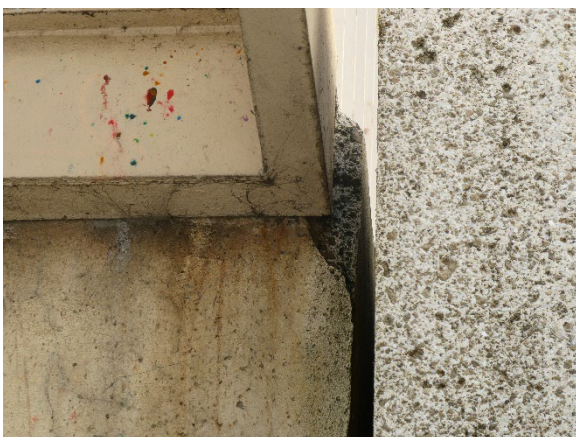
Incipient spalling at the joint beneath metal stair platform, typical condition. Northeast elevation pictured.

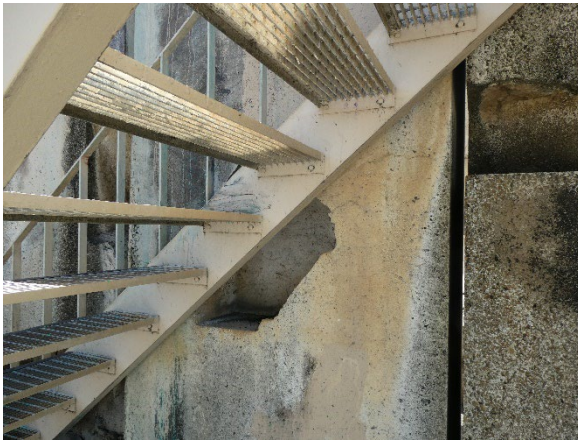
The original steel stairs, viewing platforms, and railings are painted a light buff color similar to the color of the finished concrete, and are in generally good condition. There is some soiling on the underside of the stairs and landings, as well as some localized surface corrosion and minor paint loss. Where the steel viewing platforms connect to the concrete structure, there are incipient spalls and evidence of corrosion, however it is not clear from only visual assessment whether the corroding member is the connection between the platform and the concrete or just other reinforcing within the concrete. This condition may compromise the long-term stability and safety of the platforms and should be evaluated further, particularly if the platforms are to remain accessible.

Typical condition of the underside of the painted steel stairs on the east side of the fountain, exhibiting soiling but minimal if any corrosion.

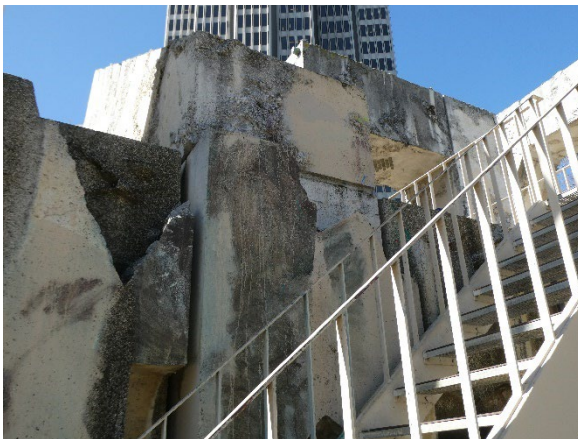
Typical overall condition of painted steel stairs on the east side of the fountain.

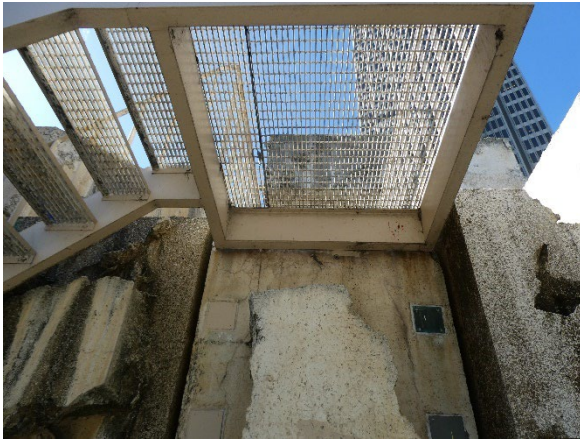
Typical condition of underside of east viewing platform landing and stairs.

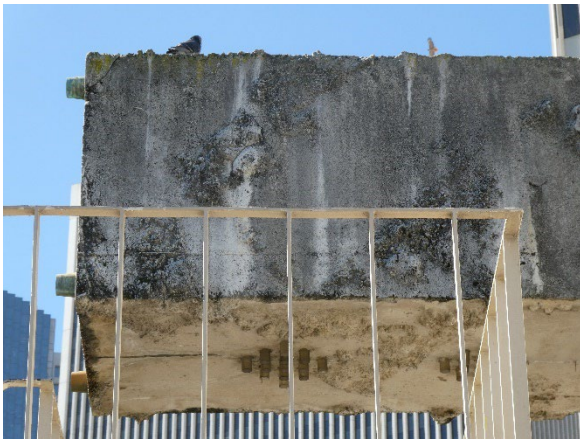
Typical condition of platform and landing railings.

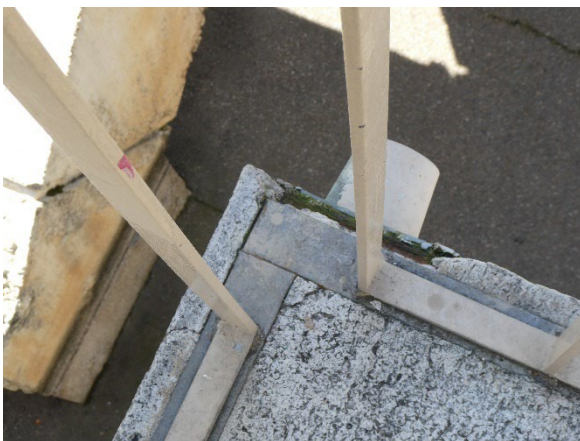
Detail of spalled concrete at the edge of the railing attachment.

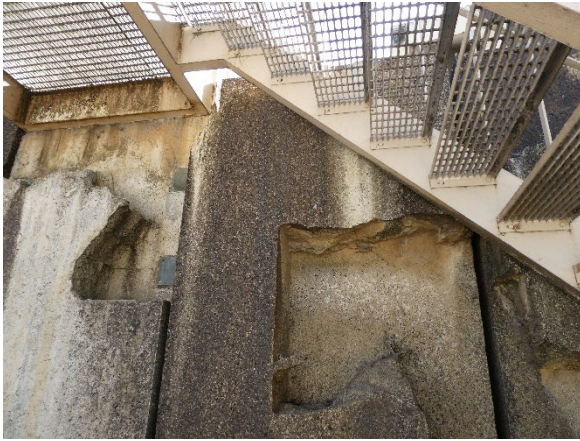
Typical condition of the painted steel stairs with soiling, and some minor surface corrosion at edges of the landing frame.

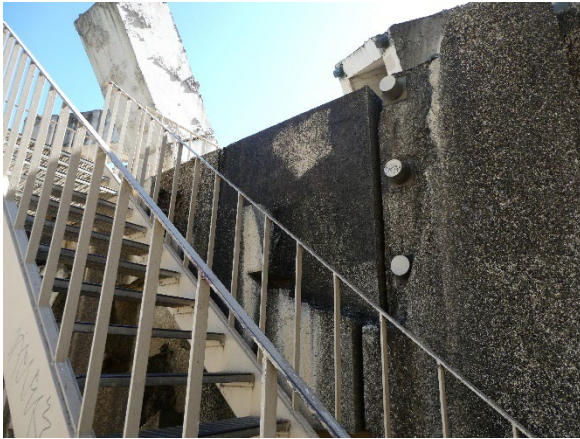
Typical condition of the painted steel stairs to the viewing platforms.

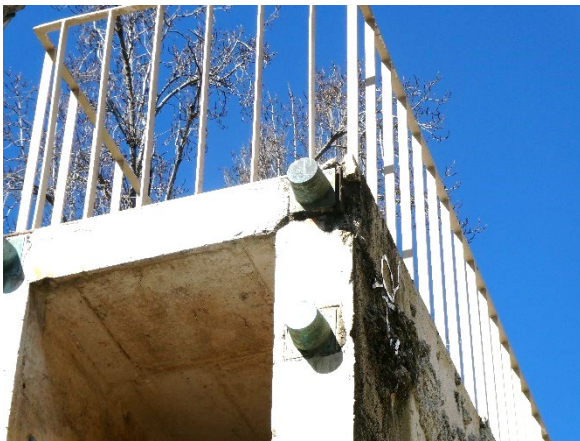
Detail of typical cracking and spalling around the bottom of the viewing platforms due to corrosion of the supporting and reinforcing steel.

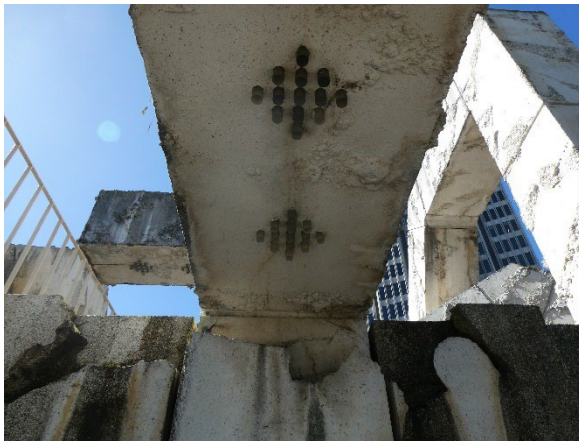
The light fixtures do not appear to still be functional, and a few of the glass cylinders have chipped or broken off (approximately 6 of the latter), however most of the glass cylinders are intact and appear to be in otherwise good to fair condition. Some have been partially painted where graffiti has been covered. The electrical lamping components of the light fixtures were not evaluated as part of this assessment, however the maintenance report from RPD indicates that the lighting system has deteriorated beyond repair and requires replacement to restore functionality.

Typical glass cylinders on the underside of the hollow, pre-cast concrete arms.

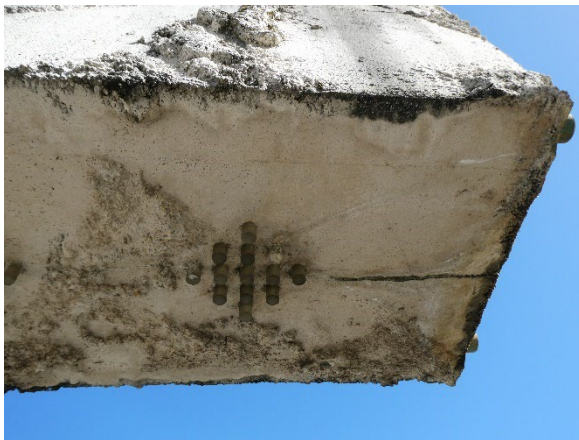
Detail of glass cylinders in the hollow pre-cast concrete arms, associated cracking, and efflorescence.

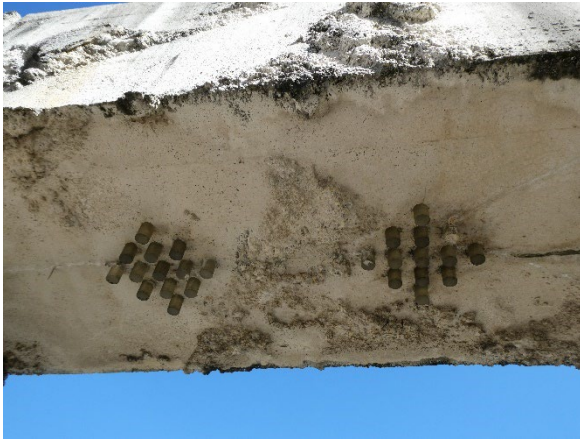
Detail of glass cylinders in the hollow pre-cast concrete arms, associated cracking, and efflorescence.

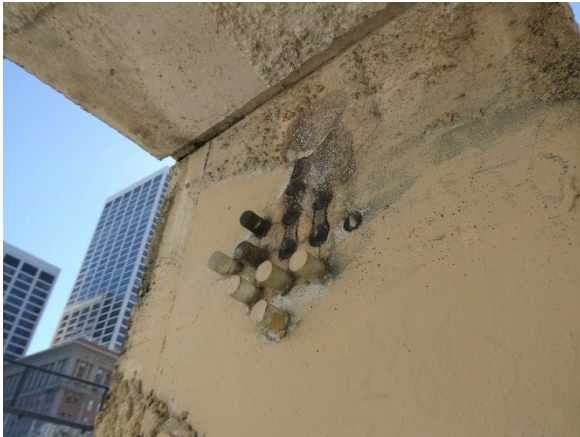
Detail of broken and painted glass cylinders in the hollow pre-cast concrete arms.

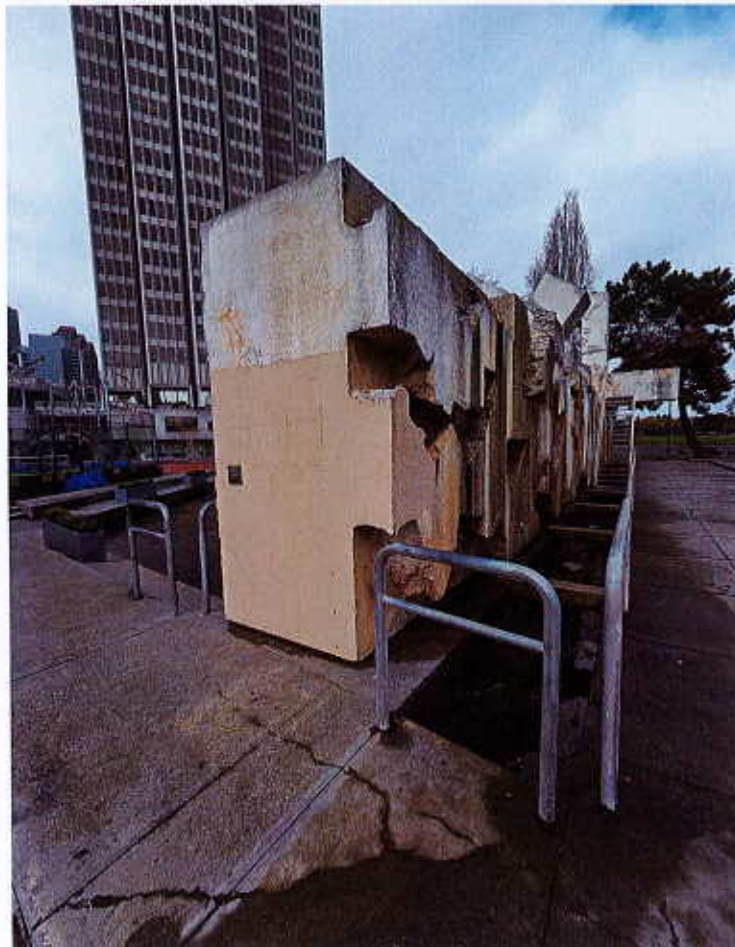
Photo 4. Rear wall – no reinforcing steel was found.

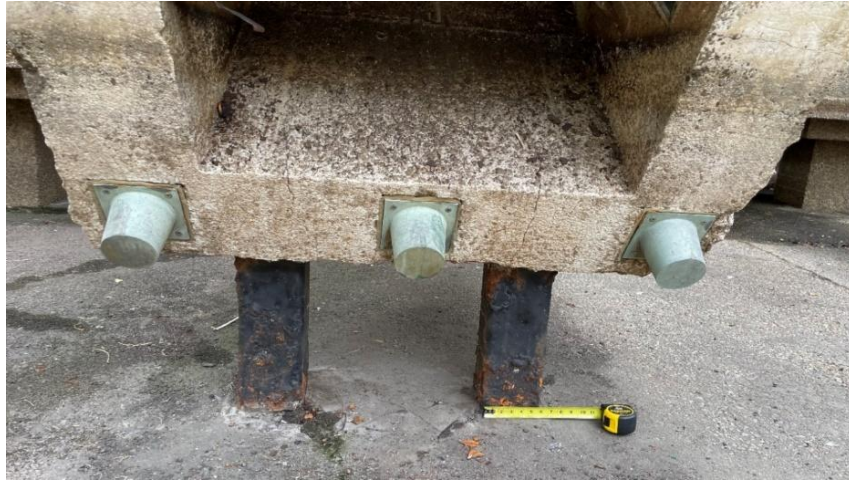
Various signs of structural damage and deterioration due to corrosion were observed during the site observation. At the floor of the sunken pool, various precast frame sections were observed to be supported on 6x6 steel tube pedestals or concrete pedestals. All the steel tubes were noted to be heavily corroded (reference *Figure 8*). This is expected as a result of the constant immersion in water when the fountain was operational, as well as the continued exposure to the corrosive effects of the humid San Francisco marine air. The corrosion damage observed most likely impacts the structural integrity and ultimately the capacity of these steel tubes.

Figure 8: Vaillancourt Fountain - Corroded Steel Tubes and Spalled and Cracked Concrete

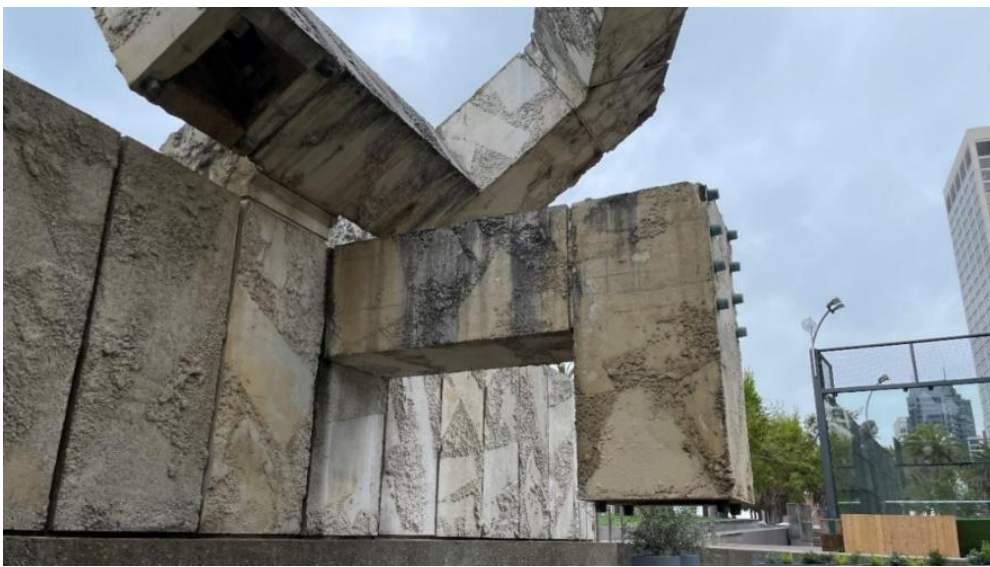
As mentioned, many of the precast concrete tube sections are connected by steel rods inserted through embedded steel tubes. These steel rods are anchored at square steel plates, which are embedded at the ends of the precast concrete tubes. The anchored steel rods are then covered with the previously noted conical caps to protect them from weather. At multiple sections, significant concrete spalling was documented behind the anchor plates. In addition, spalling at the joints between the precast concrete sections was observed in numerous locations. These spalled areas have further exposed the embedded steel anchor plates, as well as the reinforcement within the concrete, and facilitated extensive corrosion of the steel elements. Although it is not observable, the documented corrosion suggests the steel liner plates within the vertical precast concrete tubes are also likely experiencing significant corrosion and degradation.

Figure 9: Vaillancourt Fountain - Showing Spalled Ends

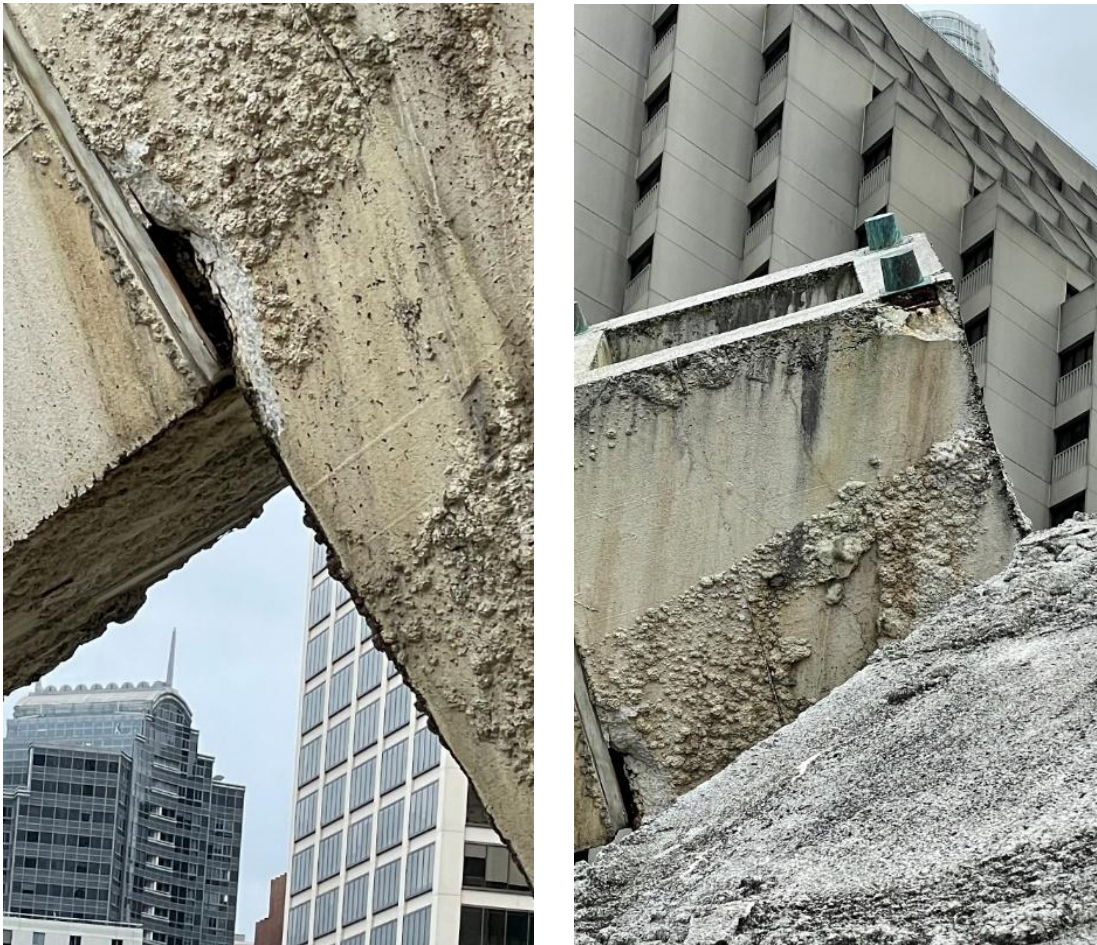
Figure 10: Vaillancourt Fountain - Spalled and Cracked Concrete and Corrosion of Steel Elements

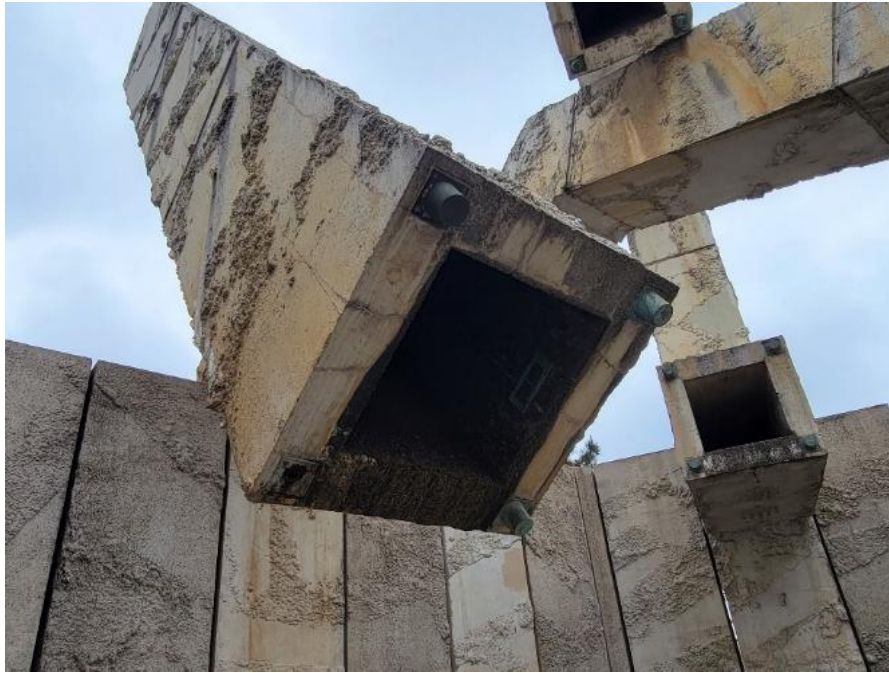
Figure 11: Vaillancourt Fountain – Showing Corroded End Plate and Absence of Thru Rod and Spalled Concrete Surface

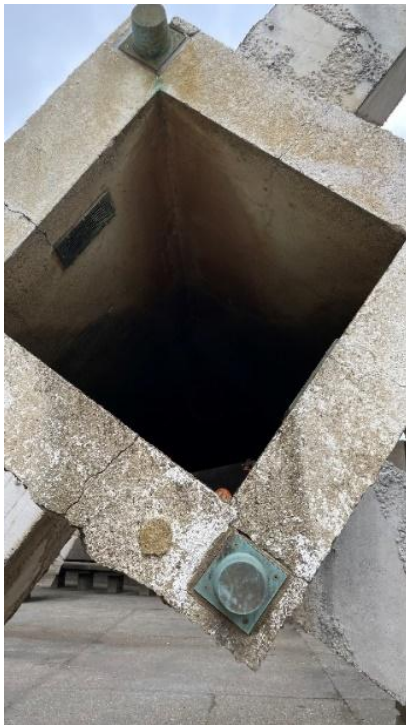
Figure 12: Vaillancourt Fountain Cracked and Spalled Concrete and Water Damage Stains

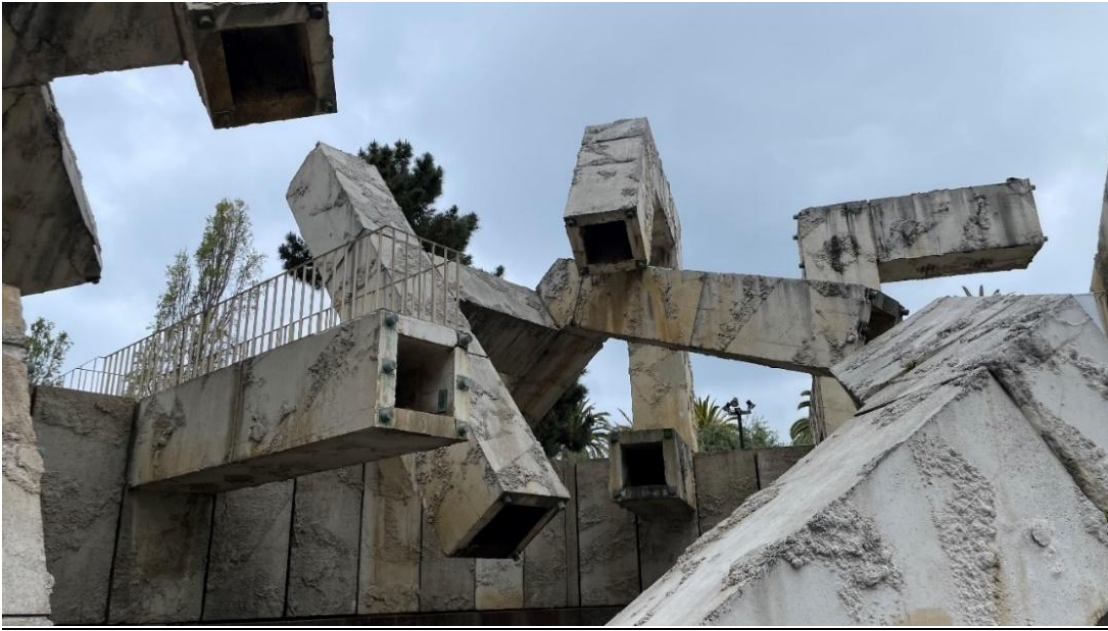
Figure 13: Vaillancourt Fountain – TS6 Frame on TS4-TS5 Assembly - Cracks and Corrosion

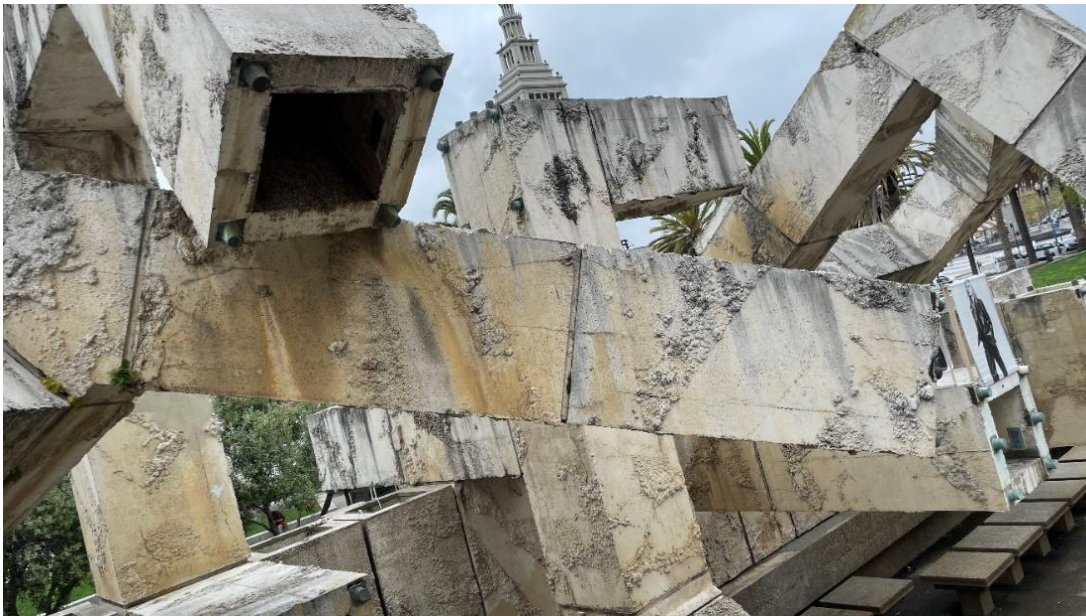
Figure 14: Vaillancourt Fountain – TS6 Frame resting on TS4-TS5 Assembly with Cracks and Corrosion Close Up

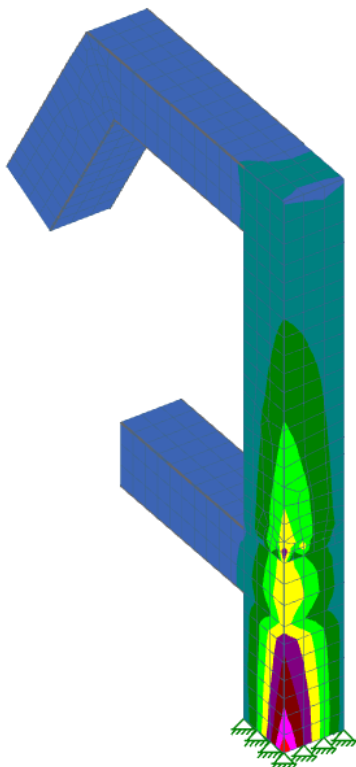
Figure 17: Stress Contours in the Precast concrete and Steel Elements
